# Manhole Inspection Summary

Manhole # S39WW\_033MH

Insp Date: **12/18/06 3:25 PM**

**Location** Address: **3116 ELLERSLIE AVE**

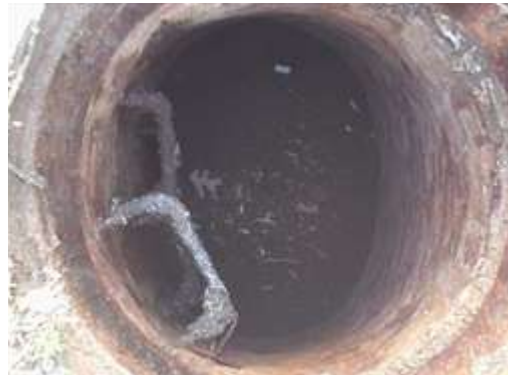
Top View

Corroded steps. Channel debris.

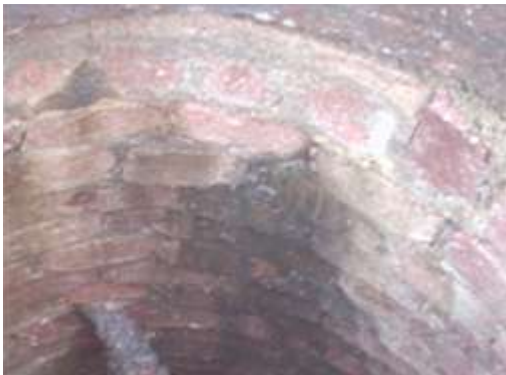
Defect

☒ **Leaks**

Condition: ☐ Sound ☐ Cracked ☐ Root Intrusion ☐ Loose Brick ☒ **Deteriorated**

Infiltration: ☐ None ☒ **Joint** ☐ Cracks ☐ Mortar ☐ Roots ☒ **Wall**

Infiltration: ☐ None ☐ Joint ☐ Cracks ☒ **Mortar** ☐ Roots ☒ **Wall**

Frame leaks. Adjustmet and Corbel deterioration and infiltration.

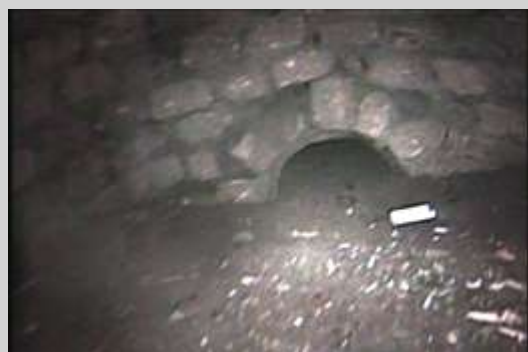
Pipe Out @ 12 O'Clock

8 in. Circular Gravity Sewer

Deposits: ☐ None ☒ **Mud** ☐ Sludge ☒ **Debris** ☐ Grease

Silt Depth: **4** (in.)

Infiltration: **Evidence**
